NONDESTRUCTIVE TESTING OF WOODEN VESSELS

Kurt A. Hansen

U.S. Coast Guard Research and Development Center
1082 Shennecossett Road
Groton, CT 06340-6096 USA

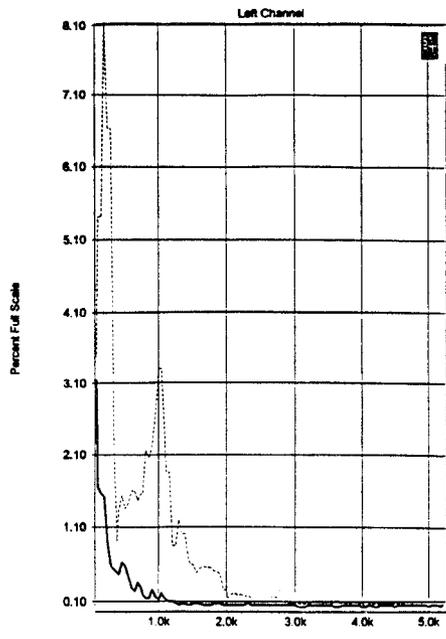
The first product demonstrated was SMART HAMMER (Patent Pending) which is a tool being developed by Bruce Pfund/Special Projects. The control component of this device includes some air actuators which can control the vibration of several impact devices. The other major part of the SMART HAMMER is a microphone connected to a recorder by which data can be fed to the computer for processing. The computer analysis basically performs the function of an experienced surveyor's ear, tracking the frequency response to determine the good sections versus the questionable areas. The difference in the good and loose areas can be easily seen in Figure 1 where individual graphs at two specific times are shown. A sharp-tipped probe was also attached to the vibration piece and used on individual fasteners in an attempt to see if the response was different for good and questionable fasteners. No differential sound was noted for any of the clinched fasteners but showed promise previously when tested on very loose fasteners.

FIGURE 1. Results from SMARTHAMMER
(Dotted line = good plank, solid = rotten)

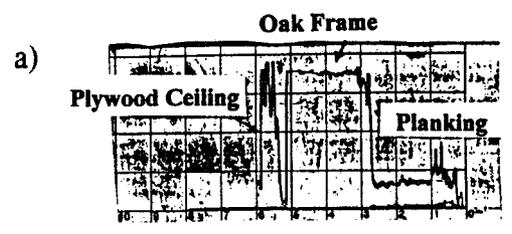
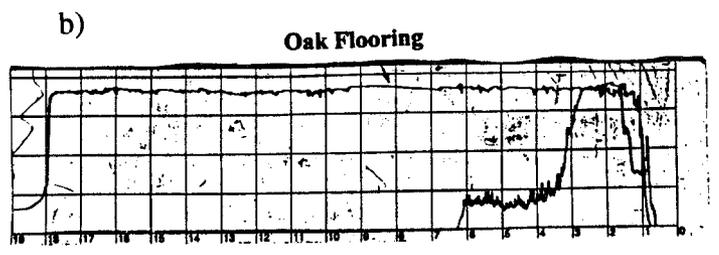
One of the techniques demonstrated was the use of specialized drills which can be used to detect decay and voids below the surface of the wood. These are normally used for large members such as bridge structures. There are systems on the market which drill holes smaller than 1 mm and can penetrate up to 16 inches into wood. The model demonstrated was the RESISTOGRAPH, manufactured in Germany. The RESISTOGRAPH measures the drilling resistance by measuring the electrical current needed to penetrate the wood. The results are printed out on a paper inside the machine which displays the resistance along a 1:1 scale of depth in centimeters. Figure 2 shows the lower resistance of the one-inch cedar plank, the higher resistance of the one-inch oak frame, and a small gap before the drill penetrates the plywood ceiling on the inside of the hull. Even though the hole drilled is very small, this technique would be considered a destructive test if used on the outer hull. If used on structure members on the inside of a vessel which are not responsible for watertight integrity, the hole would not be expected to cause sufficient damage to cause problems. Structural members, such as the oak frames and floors could be evaluated using this model.

FIGURE 2. Results from RESISTOGRAPH.

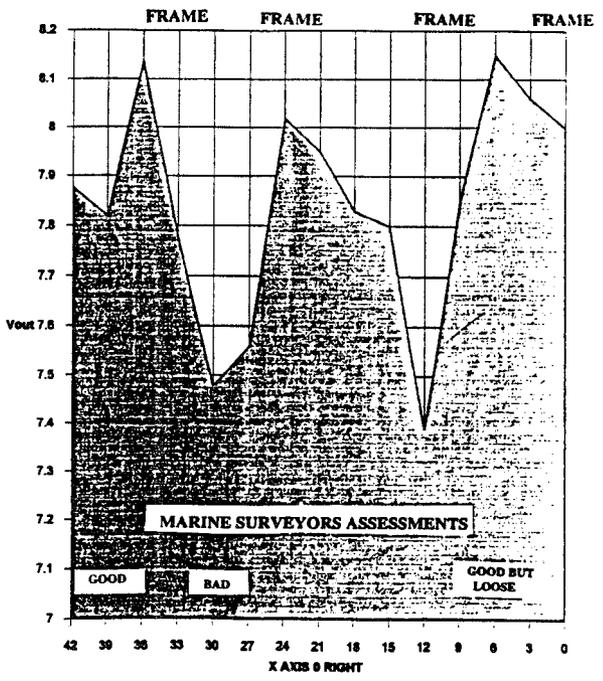
Locations above the waterline were tested in Areas 1 and 5. In Area 1, dips in the readings were seen at two areas where the marine surveyors had indicated problems. (See Figure 3) In fact, it was marked right on the wood. But the dip at the 12 inch area is not consistent, especially since it is at a frame where the oak and fasteners should increase the readings. Area 5 was expected to be good and the data generally agreed except for a couple of areas on the left and top of the area (see Figure 4). Again, the data did not match the vessel frames as expected.

FIGURE 3. Results of CAPCIFLECTOR of Area 1.

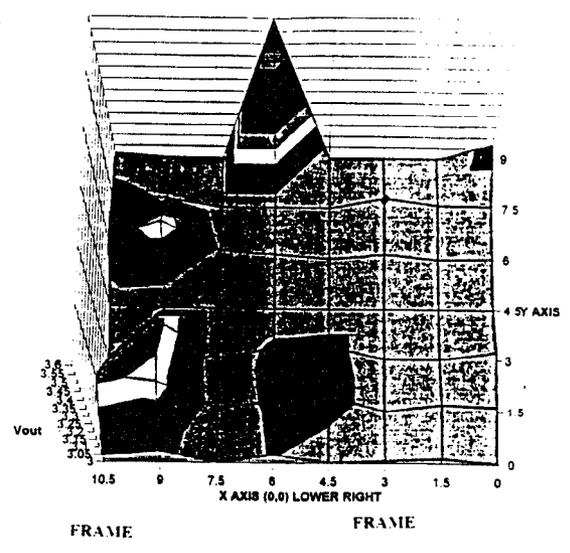
FIGURE 4. Results from CAPCIFLECTOR of Area 5.

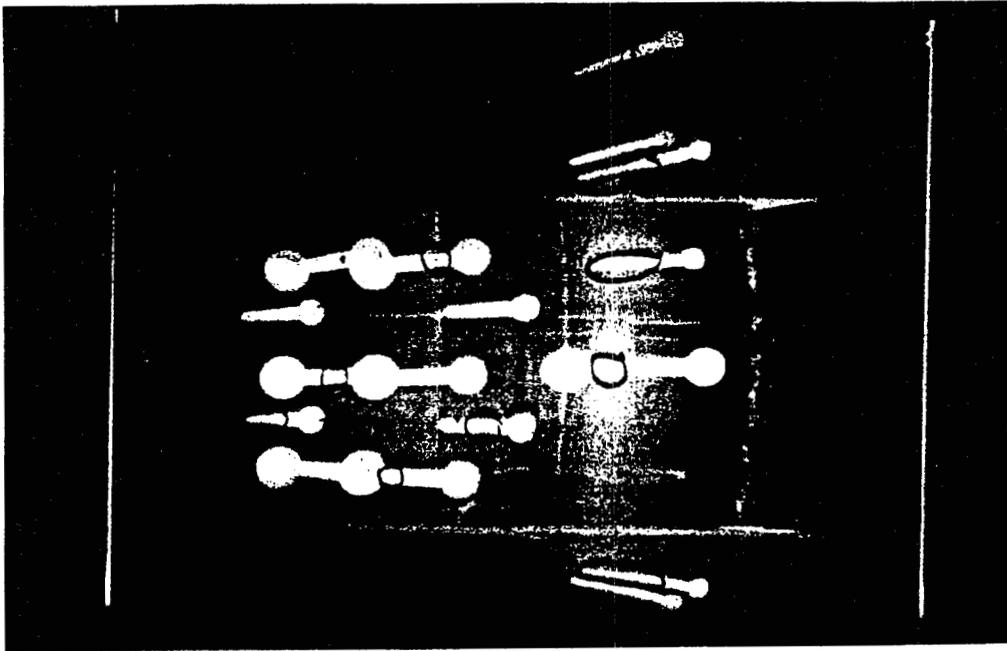
The first shots for both systems were taken of the test fixture built for this experiment. These shots were taken of the upper right-hand portion of the test fixture. The conventional x-ray results (Figure 5) shows the first problem encountered; the angle at which the shot is taken makes fasteners at different locations overlap and even appear not to be in the location thought. The shanks of the fasteners which were filed are easily seen. In the real-time shot (see Figure 6), a more limited area is covered. The results are a positive picture so that this shot is a mirror image of the conventional x-ray. The defects are easily seen.

FIGURE 5. Conventional x-ray of test fixture

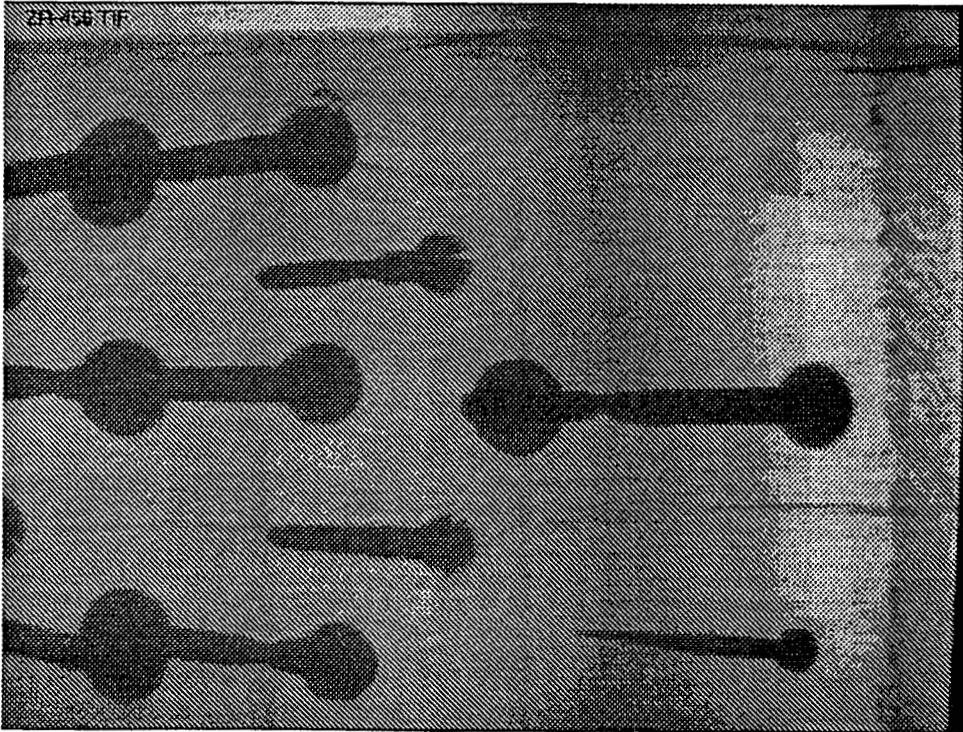
FIGURE 6. Real-time x-ray of test fixture

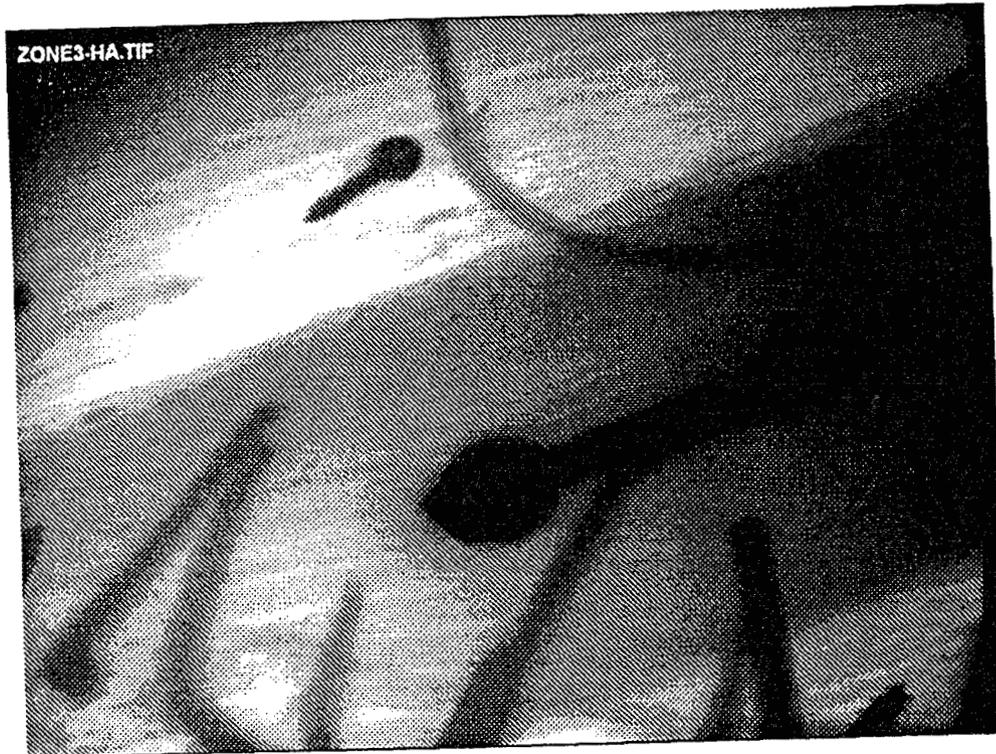
that in the x-ray, the outlines of the good fasteners are distinct. The lighter color near the head is the bung placed over the fasteners. Closer to the waterline, the fasteners in the x-ray begin to have less distinct shapes and almost seem to have a halo-type ring around them. In this case, the oxide created by the corrosion process has a different density. The real-time x-rays of this area are not as clear. Figure 8 shows an angled shot taken at the same location as the conventional one.

FIGURE 8. Real-time x-ray of stern.

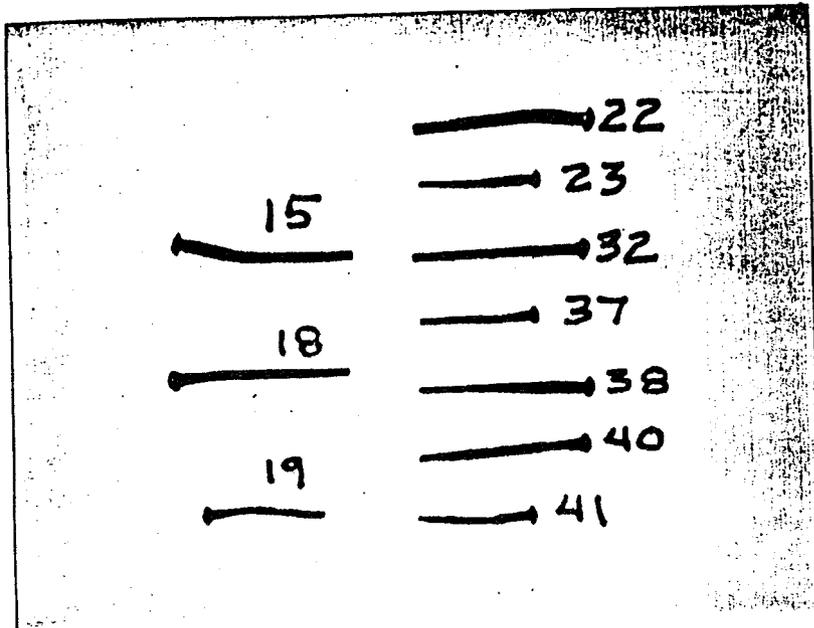
FIGURE 10. Fasteners removed from bow.

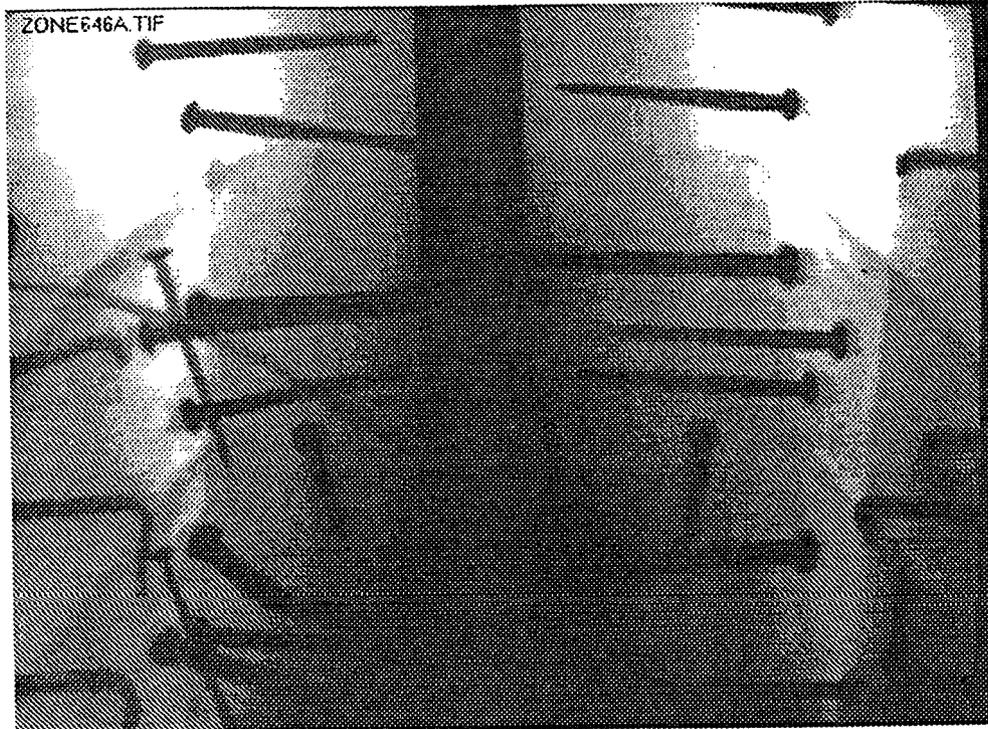
The real-time x-rays were also taken with the source inside of the vessel. The butt-in brass can be seen just above the center in Figure 11. The lower energy real-time system had some difficulty penetrating the large amount of structure.

FIGURE 11. Real-time x-ray of bow.

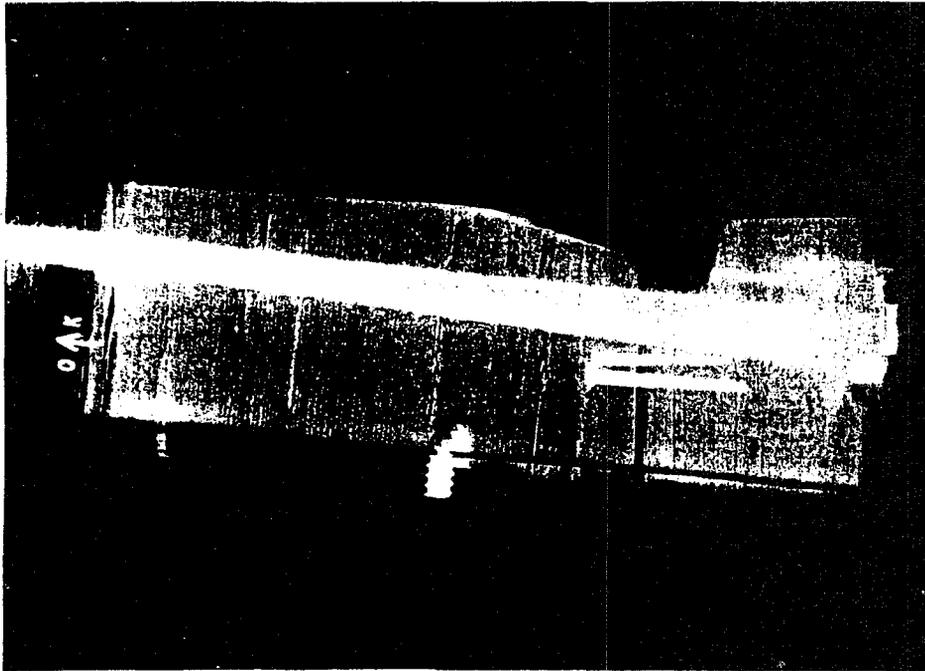
A set of x-rays were taken of saved pieces of the hull in a controlled laboratory setting. The first set of x-rays were taken of a 6-inch square section of the keel which contains two through-bolts. The necking of the fasteners can be seen in the conventional (Figure 12) and the real-time shots (Figure 13) taken at zero degrees. The effect can be seen in the other shots as well (Figure 14) taken at a 30 degree angle. This shot also shows how fasteners can hide behind other ones so that orientation of the source is important. Finally, the size of the bolts on the X-ray varies with the distance that the film is from the fastener. Thus, rod "B", which is closer to the film, has truer dimensions which can be measured right off of the film, especially for the 30 degree film. Larger distances increase the angles and therefore increase distortion.

FIGURE 12. Conventional x-ray of bolts taken at zero degrees.

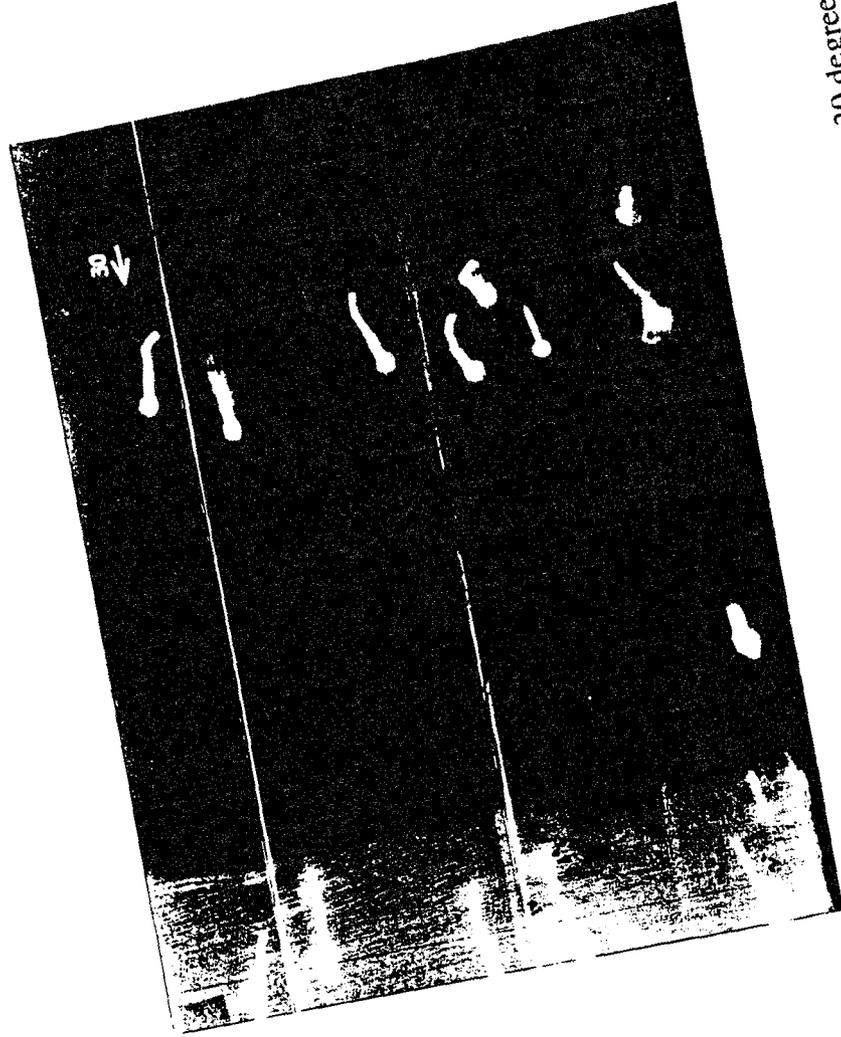
A series of shots utilizing both conventional and real-time techniques were also taken of a section of the hull dissected from near the keel. The objective of this group of shots is to provide some standard types of arrangements which will help film interpretation. It is also important to note that these shots were not taken through the entire so the result is a clearer picture. The shots were taken at 30 (Figures 15 and 16) and 45 degrees (not shown here) from the side and cover sections of two frames. Both techniques indicate questionable fasteners, but the conventional x-rays provide more detail. A real-time shot was taken at a 60-degree angle (see Figure 17). Although the condition of the fasteners can be determined, the distortion is very severe and this amount of angle should only be used for extreme cases.

FIGURE 15. Conventional x-ray of planks taken at 30 degrees.

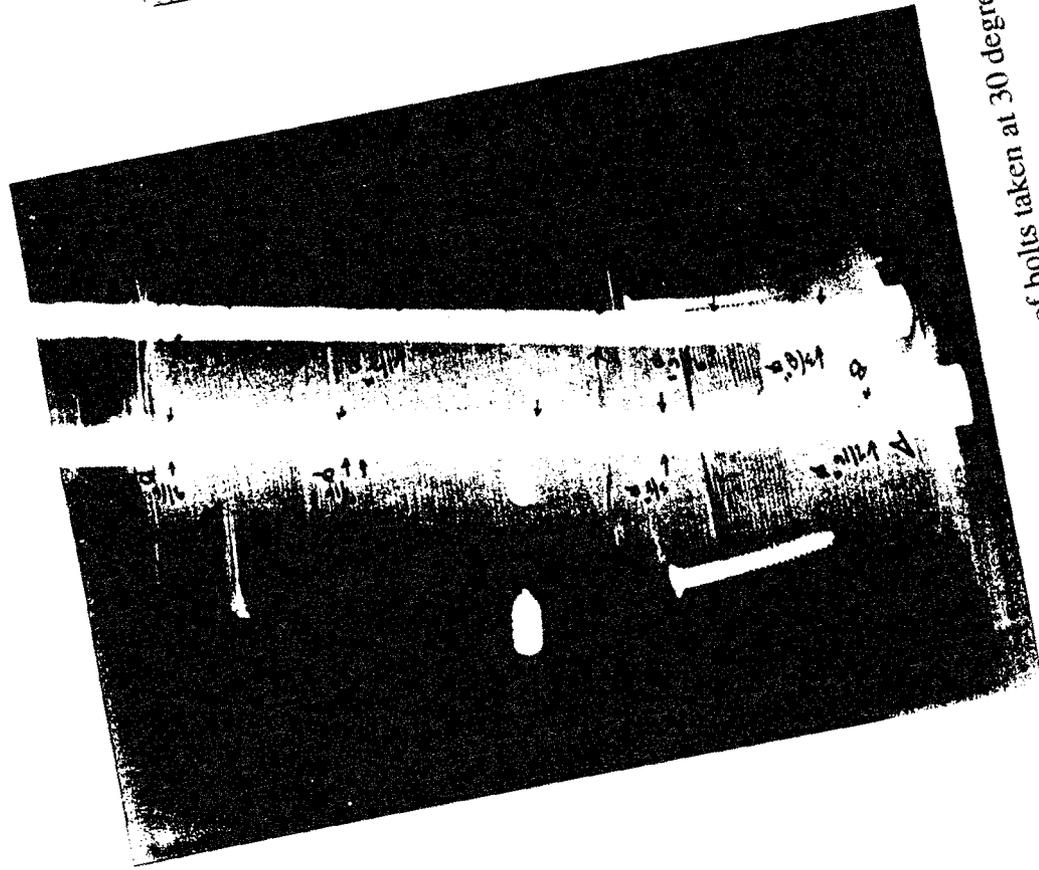
FIGURE 14. Conventional x-ray of bolts taken at 30 degrees.

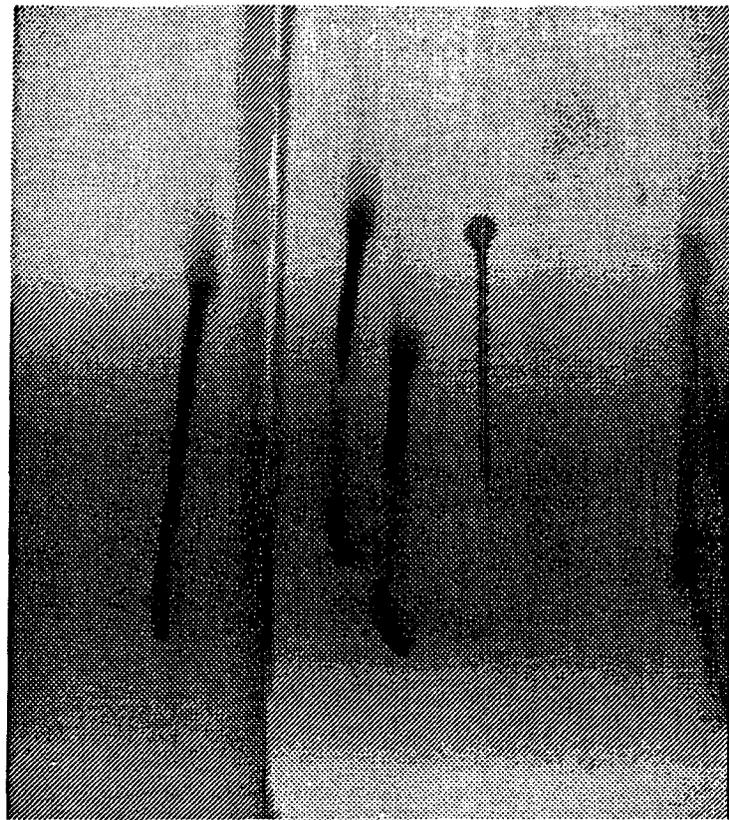
FIGURE 17. Real-time x-ray of planks taken at 60 degrees.

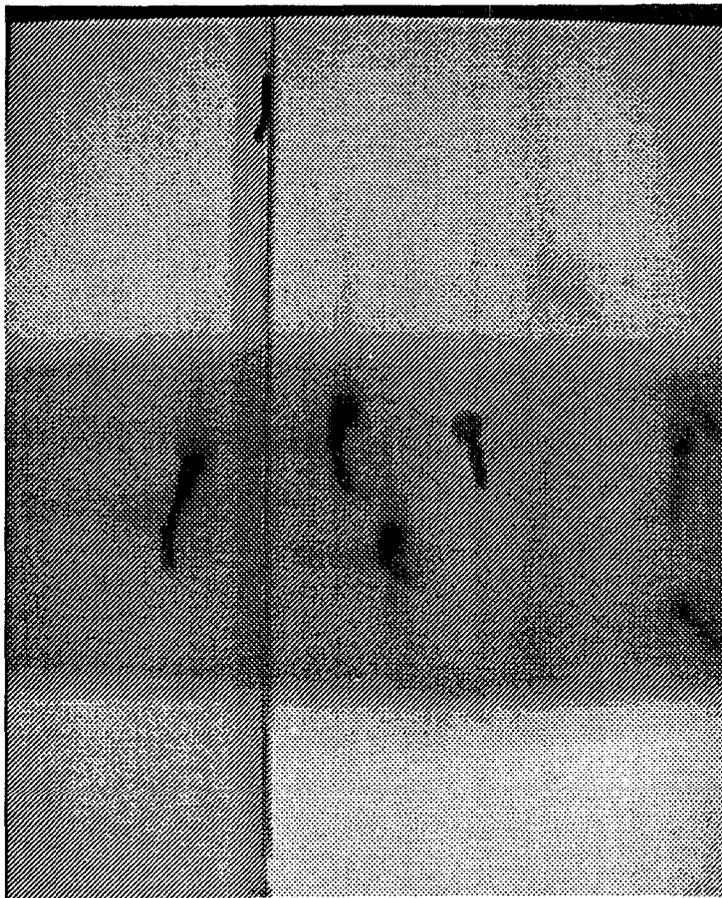
FIGURE 16. Real-time x-ray of planks taken at 30 degrees.
